**West Manchester Township  
Invitation to Bid  
for the  
Rainbow Circle Area Stormwater CIPP Repairs Project**

## Inspection report

Date: <b>9/23/2022</b>	Work Order:	Weather:	Surveyed By: <b>Stew Eleftheriou</b>	Certificate Number: <b>U0318070300187</b>	Pipe Segment Ref.: <b>CB9-CB10</b>
Year laid:	Pre-cleaning: <b>No Pre-Cleaning</b>	Direction: <b>Downstream</b>	Pipe Joint Length:	Total Length: <b>170.2'</b>	Length Surveyed: <b>170.2'</b>

**RAINBOW CIRCLE  
 CCTV INSPECTION**

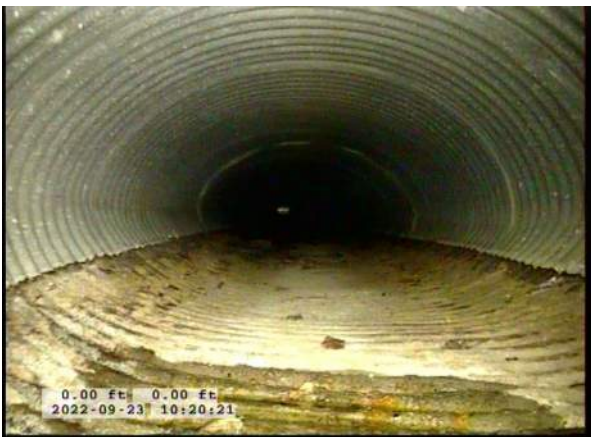
3, 00:00:18, 0.00ft  
 Deposits Attached Encrustation, 5% of cross sectional area from 5 o'clock to 7 o'clock, within 8 inch, Start / RUST

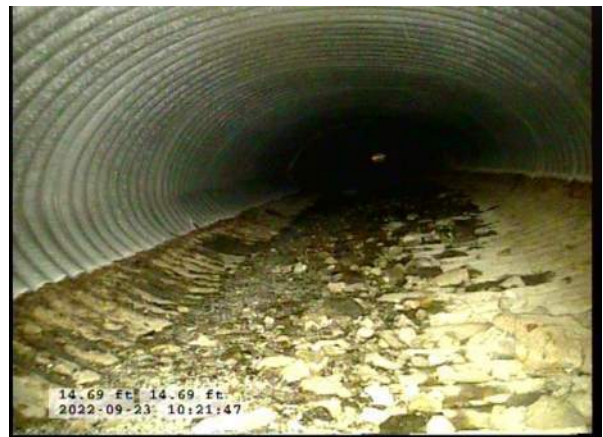
4, 00:01:24, 14.69ft  
 Deposits Settled Gravel, 5% of cross sectional area from 6 o'clock to 7 o'clock, within 8 inch, Start

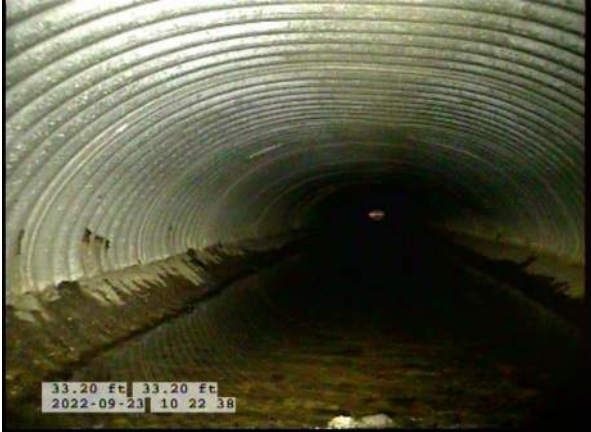
5, 00:02:12, 33.20ft  
 Deposits Settled Gravel, 5% of cross sectional area from 6 o'clock to 7 o'clock, within 8 inch, Finish

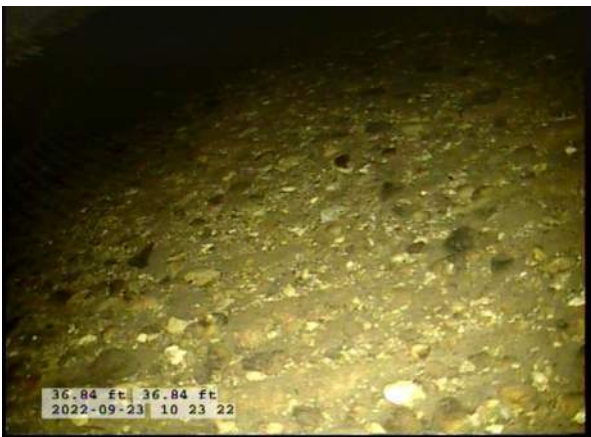
7, 00:02:37, 36.84ft  
 Deposits Settled Compacted, 5% of cross sectional area from 5 o'clock to 7 o'clock, within 8 inch, Start

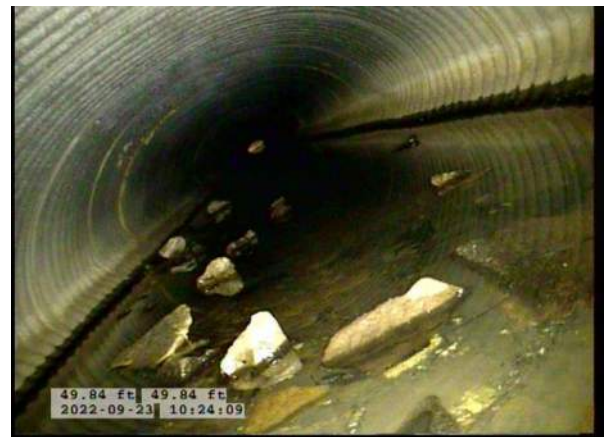
8, 00:03:22, 49.84ft  
 Deposits Settled Compacted, 5% of cross sectional area from 5 o'clock to 7 o'clock, within 8 inch, Finish

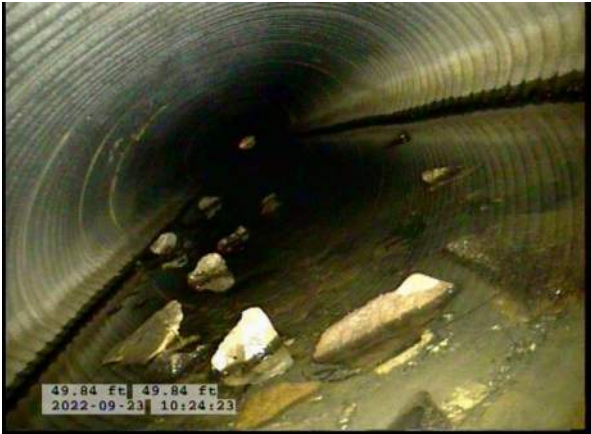
9, 00:03:24, 49.84ft  
 Deposits Settled Compacted, 10% of cross sectional area from 5 o'clock to 7 o'clock, within 8 inch, Start

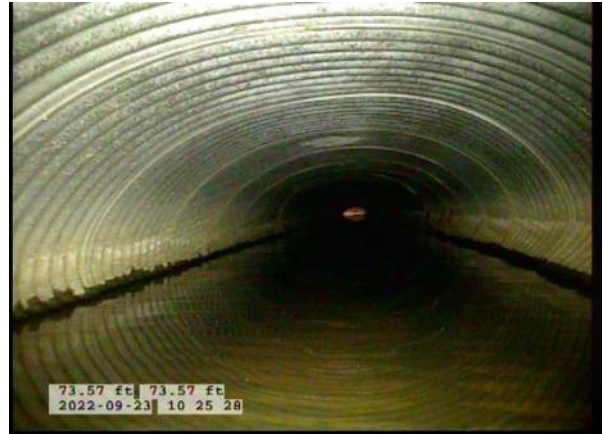
10, 00:04:25, 73.57ft  
 Deposits Settled Compacted, 10% of cross sectional area from 5 o'clock to 7 o'clock, within 8 inch, Finish

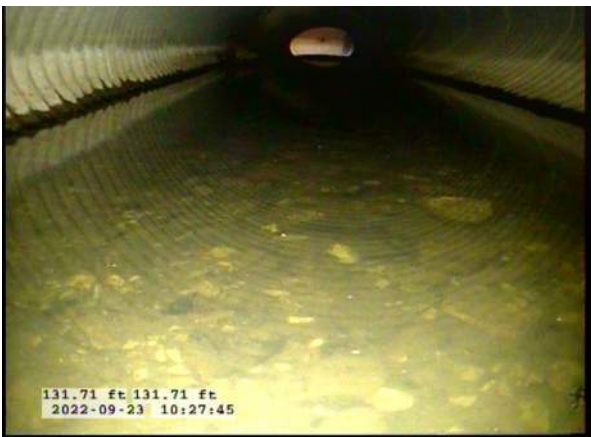
11, 00:06:09, 131.71ft  
 Deposits Settled Compacted, 5% of cross sectional area from 5 o'clock to 7 o'clock, within 8 inch, Start

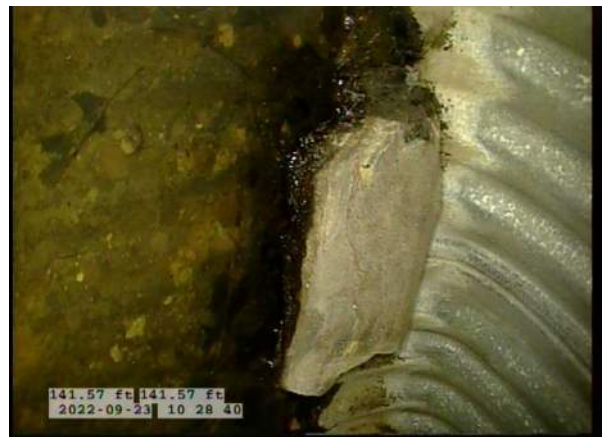
12, 00:06:37, 141.57ft  
 Obstruction Rocks, 5% of cross sectional area at 7 o'clock

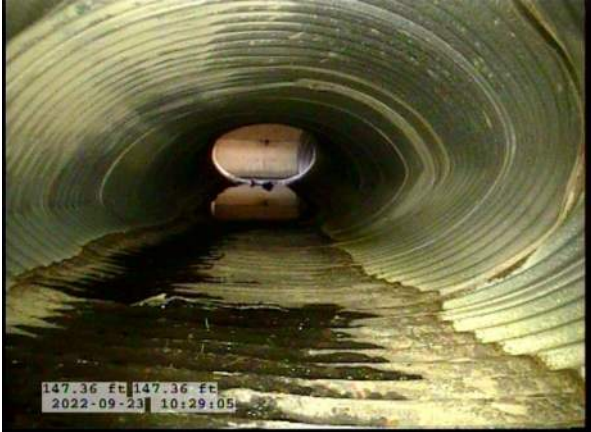
13, 00:07:00, 147.36ft  
 Deposits Settled Compacted, 5% of cross sectional area from 5 o'clock to 7 o'clock, within 8 inch, Finish

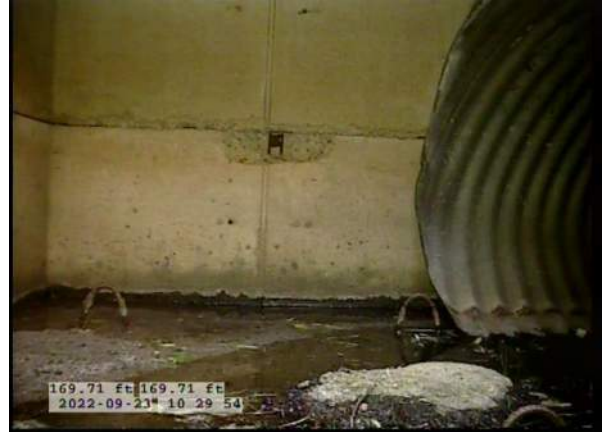
14, 00:07:41, 169.71ft  
 Deposits Attached Encrustation, 5% of cross sectional area from 5 o'clock to 7 o'clock, within 8 inch, Finish / RUST

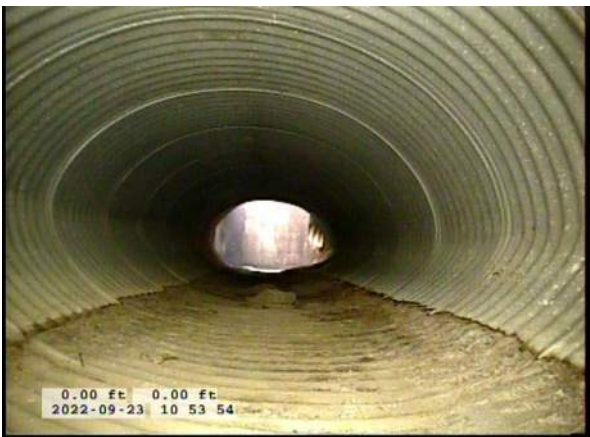
3, 00:00:16, 0.00ft  
 Deposits Attached Encrustation, 5% of cross sectional area from 5 o'clock to 7 o'clock, within 8 inch, Start

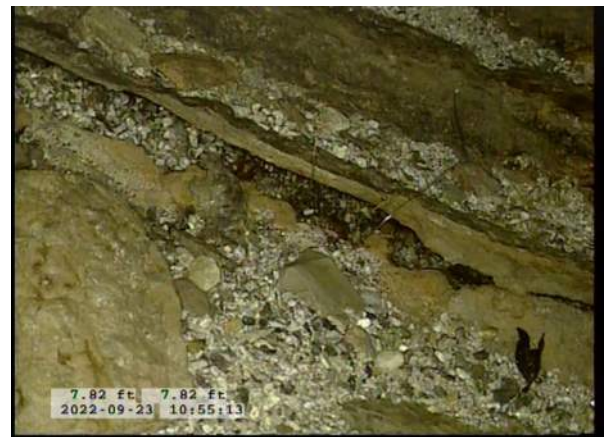
4, 00:01:06, 7.82ft  
 Surface Damage Missing Wall from 5 o'clock to 7 o'clock / BOTTOM OF PIPE STARTING TO RUST AWAY

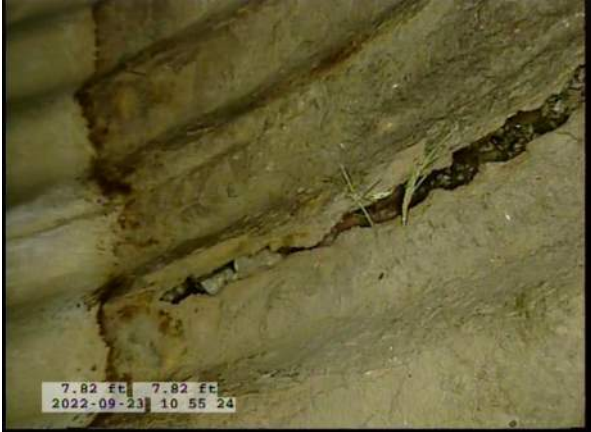
5, 00:01:06, 7.82ft  
 Surface Damage Missing Wall from 5 o'clock to 7 o'clock /  
 BOTTOM OF PIPE STARTING TO RUST AWAY

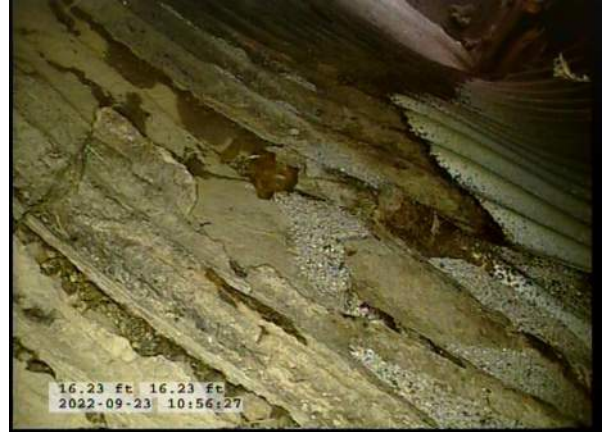
6, 00:01:53, 16.23ft  
 Surface Damage Missing Wall from 5 o'clock to 7 o'clock /  
 BOTTOM OF PIPE RUSTING AWAY

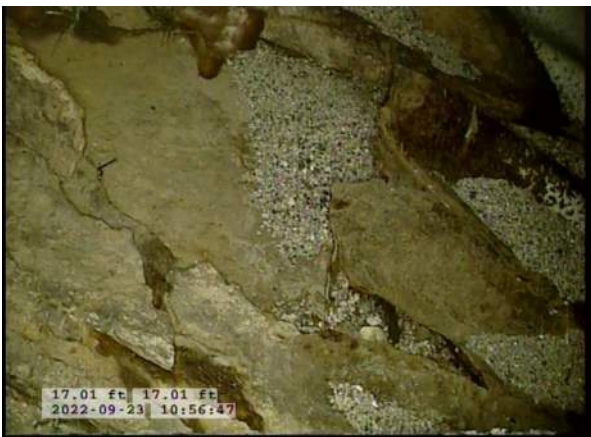
7, 00:01:53, 16.23ft  
 Surface Damage Missing Wall from 5 o'clock to 7 o'clock /  
 BOTTOM OF PIPE RUSTING AWAY

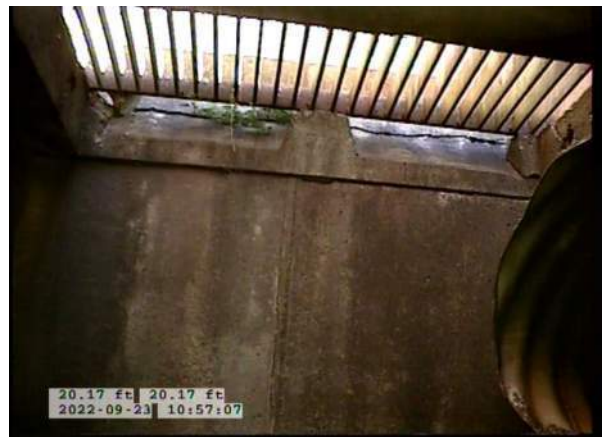
8, 00:02:30, 20.17ft  
 Deposits Attached Encrustation, 5% of cross sectional area  
 from 5 o'clock to 7 o'clock, within 8 inch, Finish

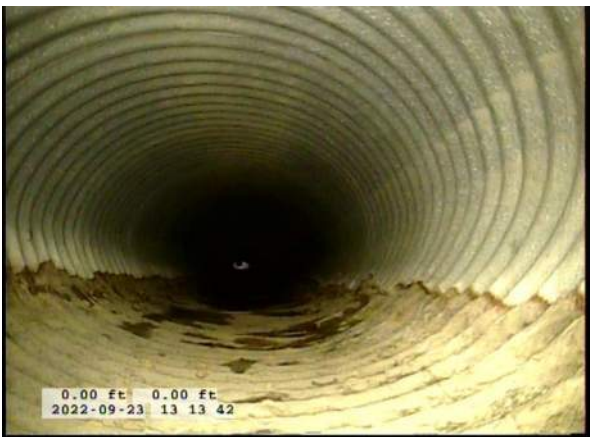
3, 00:00:17, 0.00ft  
 Deposits Attached Encrustation, 5% of cross sectional area from 5 o'clock to 7 o'clock, within 8 inch, Start / RUST

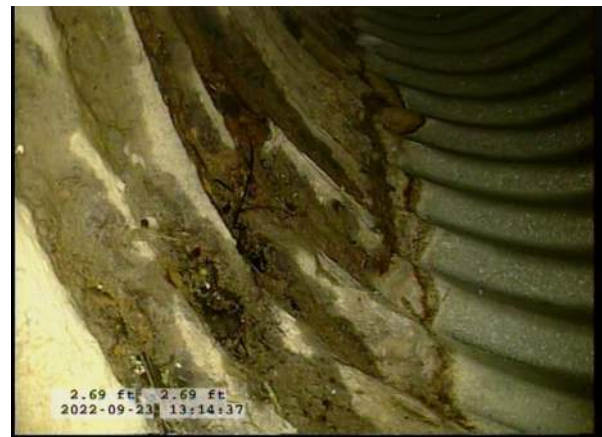
4, 00:00:44, 2.69ft  
 Surface Damage Missing Wall from 5 o'clock to 7 o'clock, within 8 inch, Start / BOTTOM OF PIPE HAS BEGUN RUSTING AWAY

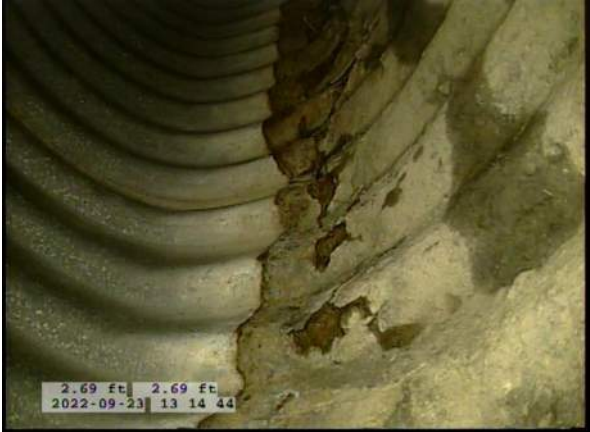
5, 00:00:44, 2.69ft  
 Surface Damage Missing Wall from 5 o'clock to 7 o'clock, within 8 inch, Start / BOTTOM OF PIPE HAS BEGUN RUSTING AWAY

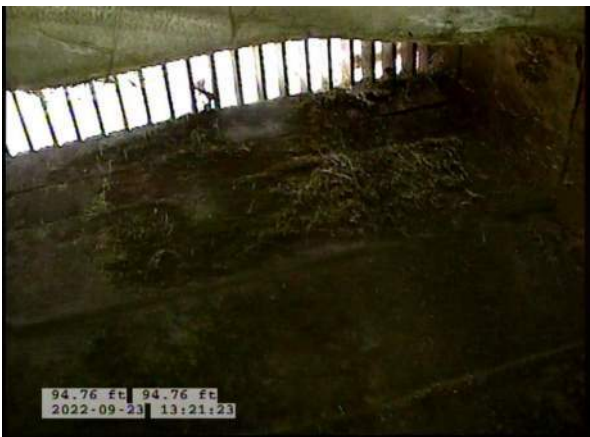
7, 00:07:20, 94.76ft  
 Deposits Attached Encrustation, 5% of cross sectional area from 5 o'clock to 7 o'clock, within 8 inch, Finish / RUST

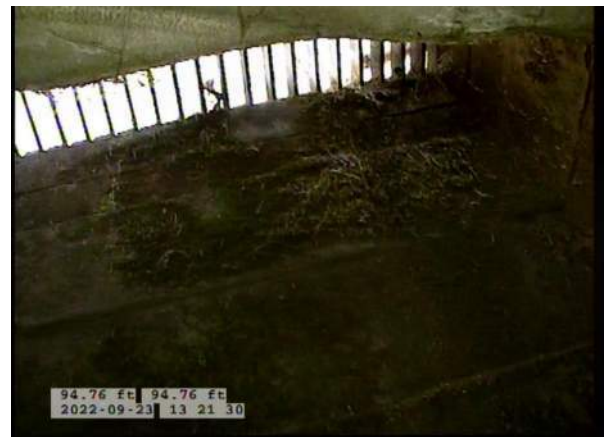
8, 00:07:23, 94.76ft  
 Surface Damage Missing Wall from 5 o'clock to 7 o'clock, within 8 inch, Finish / BOTTOM OF PIPE HAS BEGUN RUSTING AWAY
